MEMOIRS OF THE
ARCHAEOLOGICAL SURVEY OF INDIA
NO. 91

ANGKOR VAT

INDIA'S CONTRIBUTION IN CONSERVATION

1986-1993

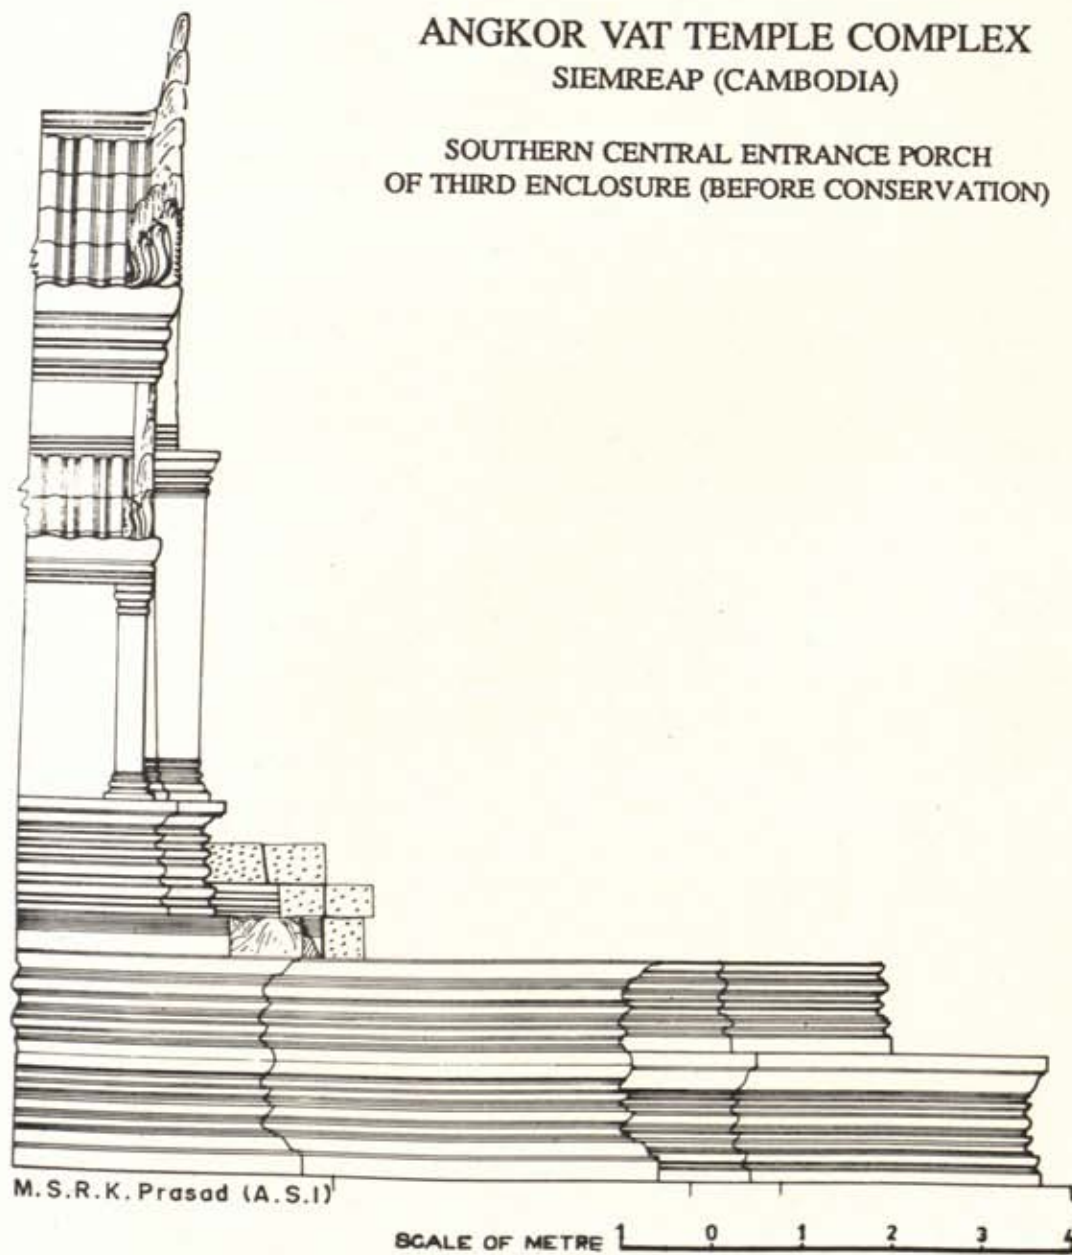
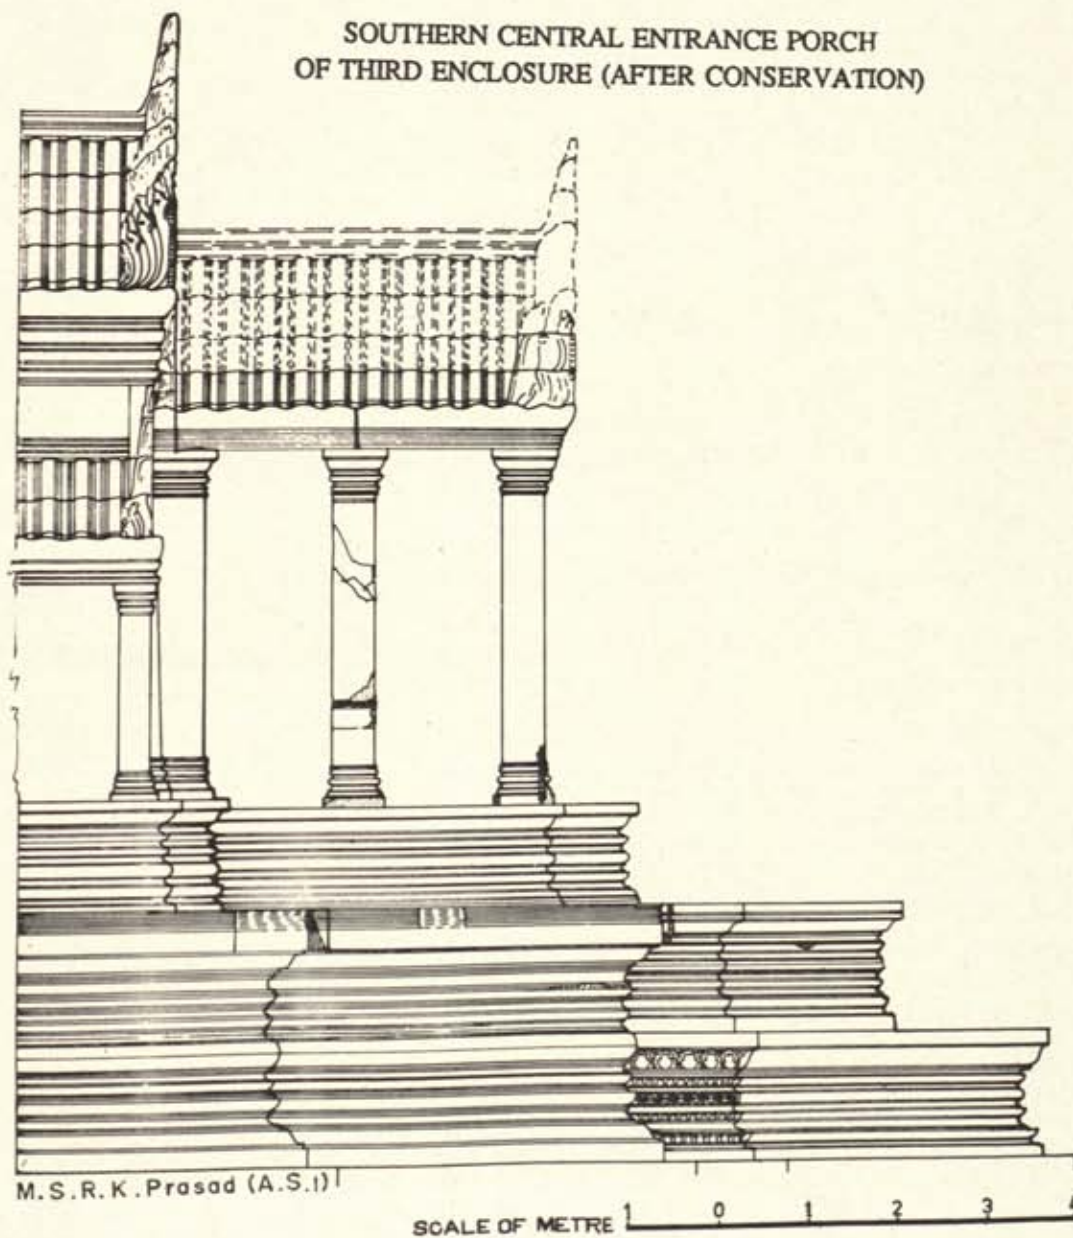
SOUTHERN CENTRAL ENTRANCE PORCH
OF THIRD ENCLOSURE (BEFORE CONSERVATION)

SOUTHERN CENTRAL ENTRANCE PORCH
OF THIRD ENCLOSURE (AFTER CONSERVATION)

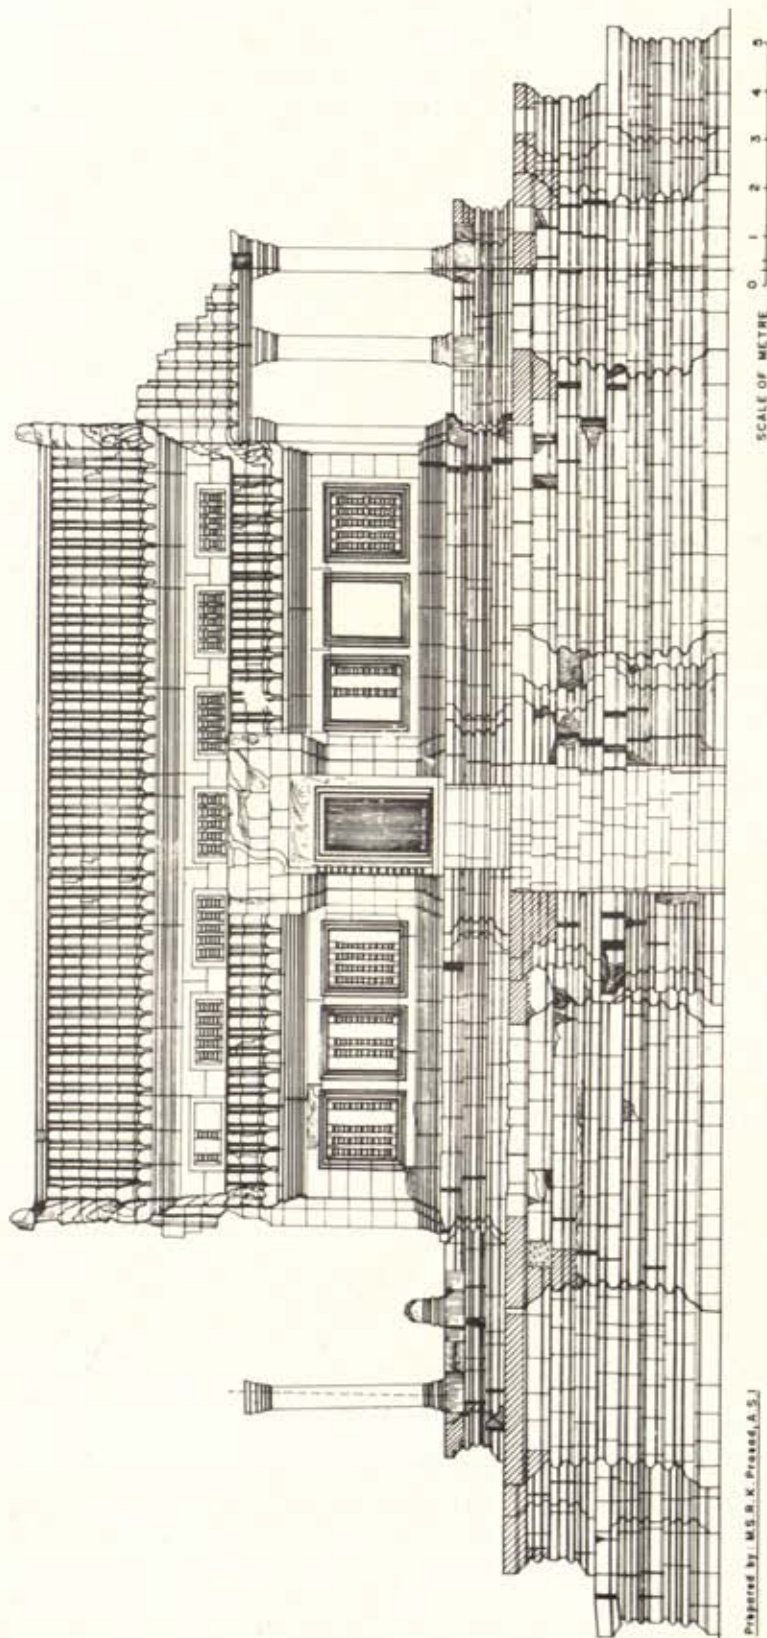
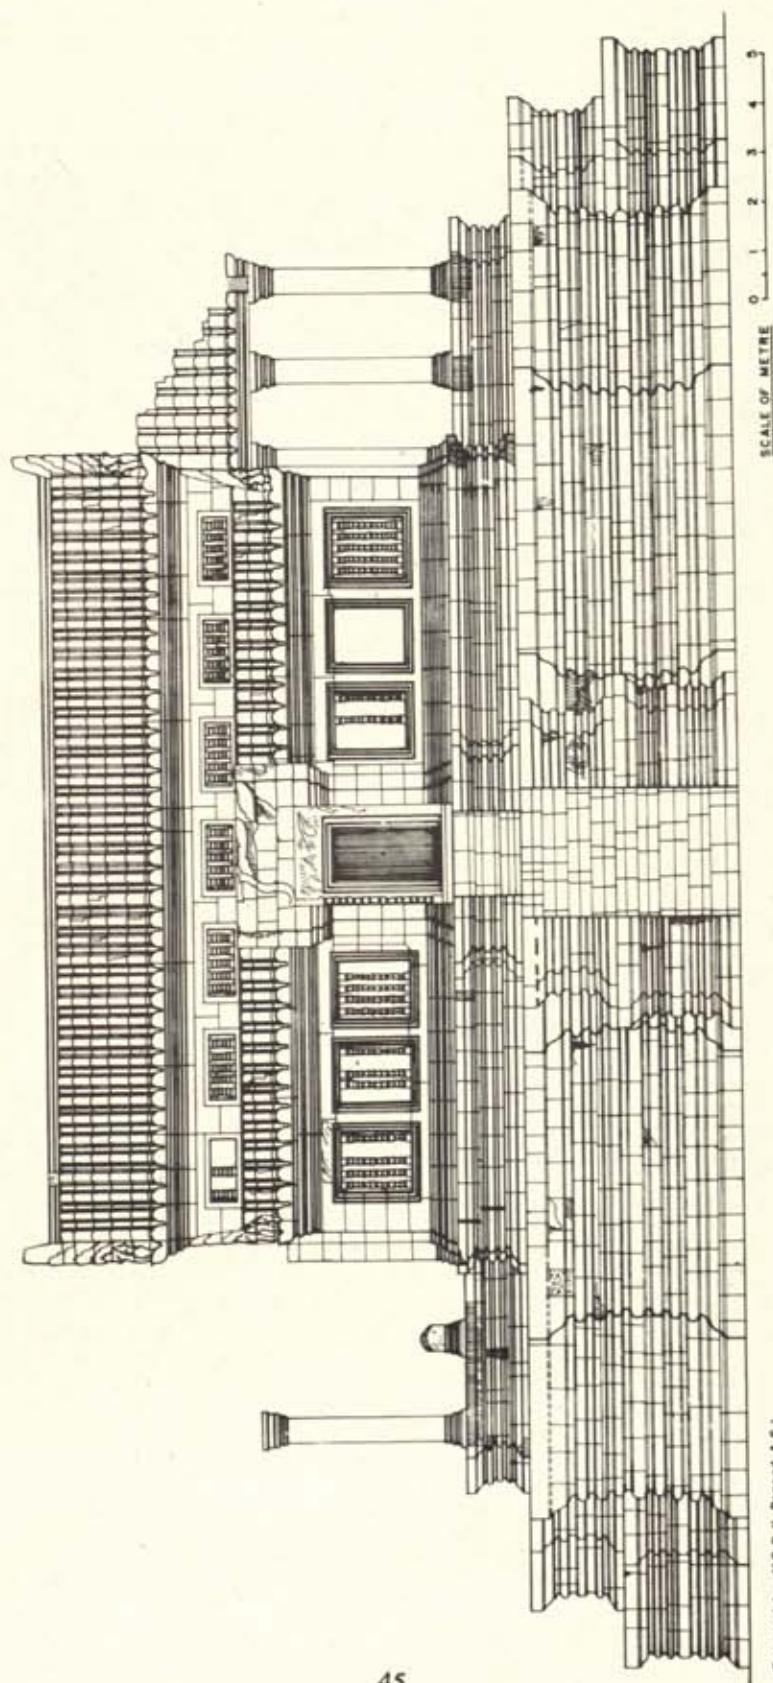
ANGKOR VAT TEMPLE COMPLEX
SIEMREAP (CAMBODIA)
NORTHERN LIBRARY BETWEEN SECOND AND THIRD ENLOSURES
NORTHERN SIDE ELEVATION (BEFORE CONSERVATION)

NORTHERN LIBRARY BETWEEN SECOND AND THIRD ENLOSURES
NORTHERN SIDE ELEVATION (AFTER CONSERVATION)

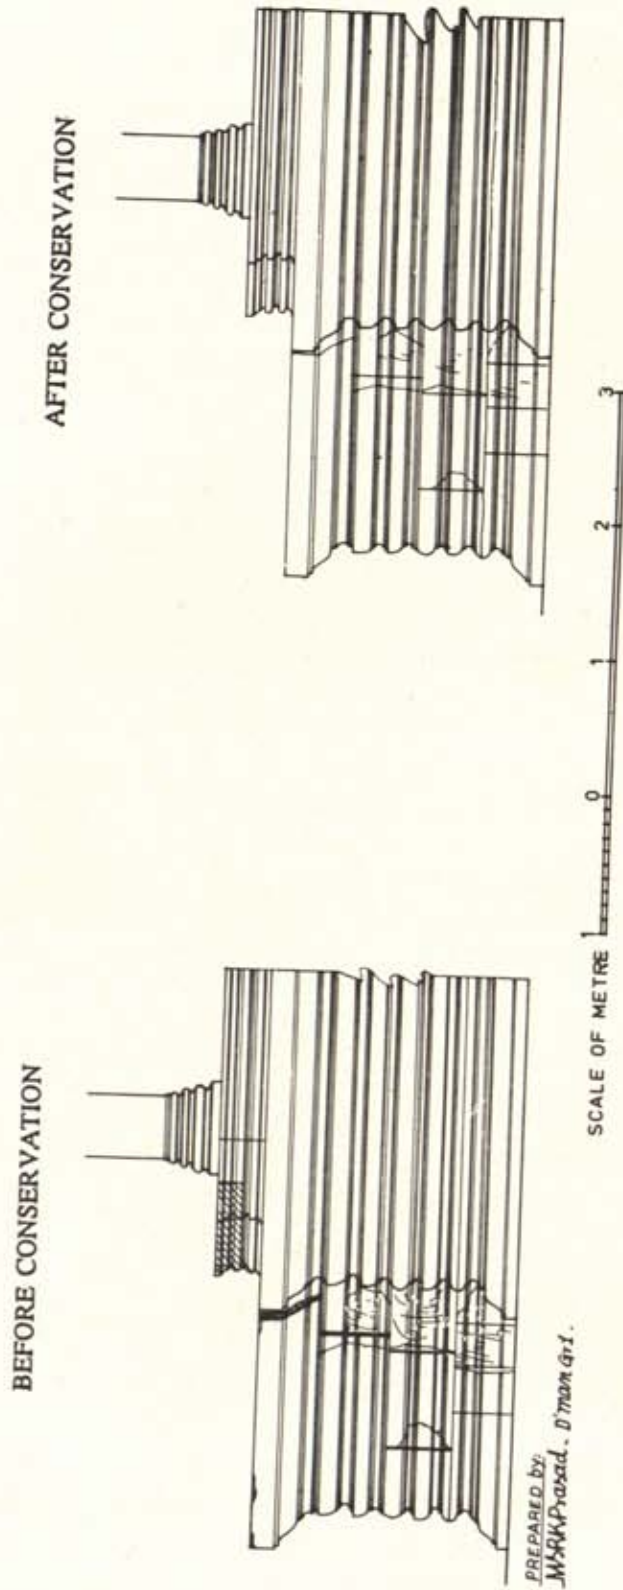
Fig. 14

NORTHERN ENTRANCE PORCH OF ANTE-CHAMBER OF SECOND ENCLOSURE

northern portion was precariously overhanging. The flooring was also dislodged and one pillar was in bad condition and the other was missing. Fortunately, the collapsed architectural members of the superstructure were lying in a heap on the floor of the porch.

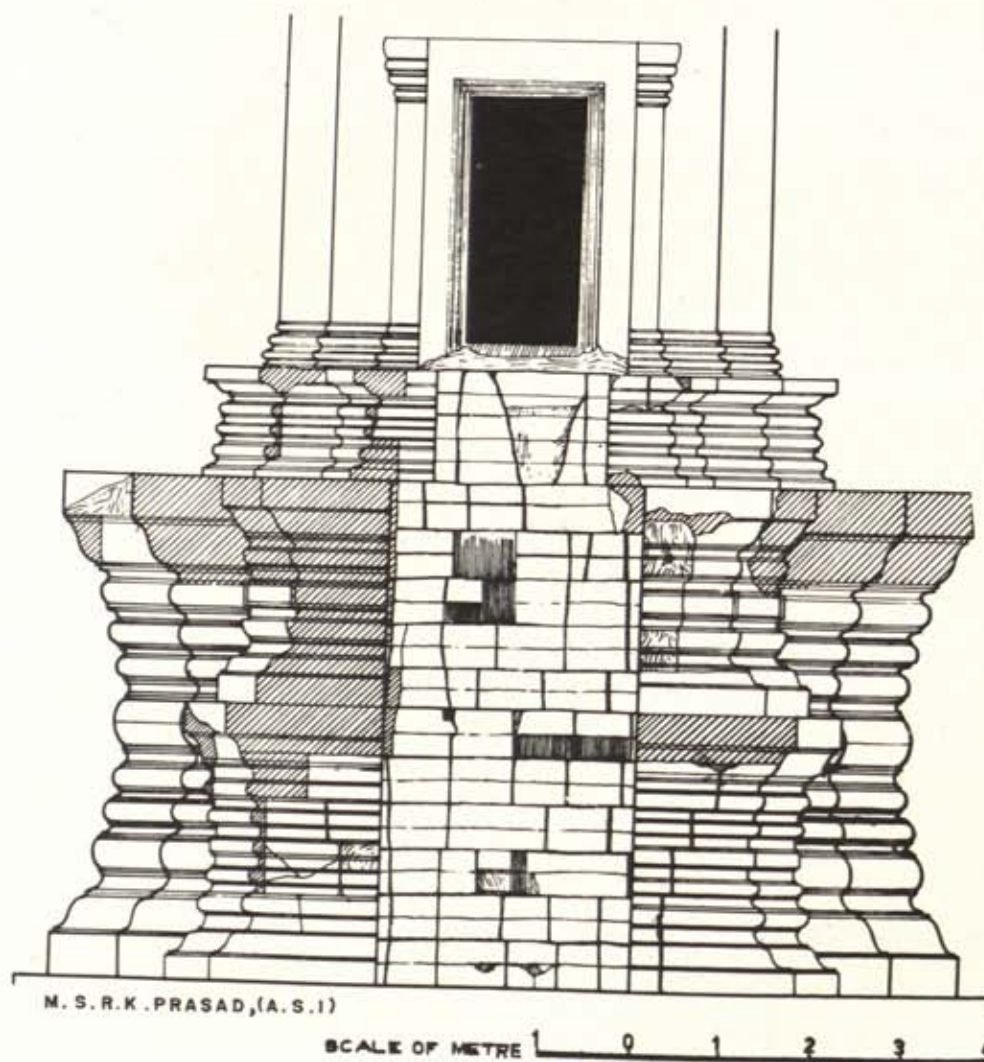
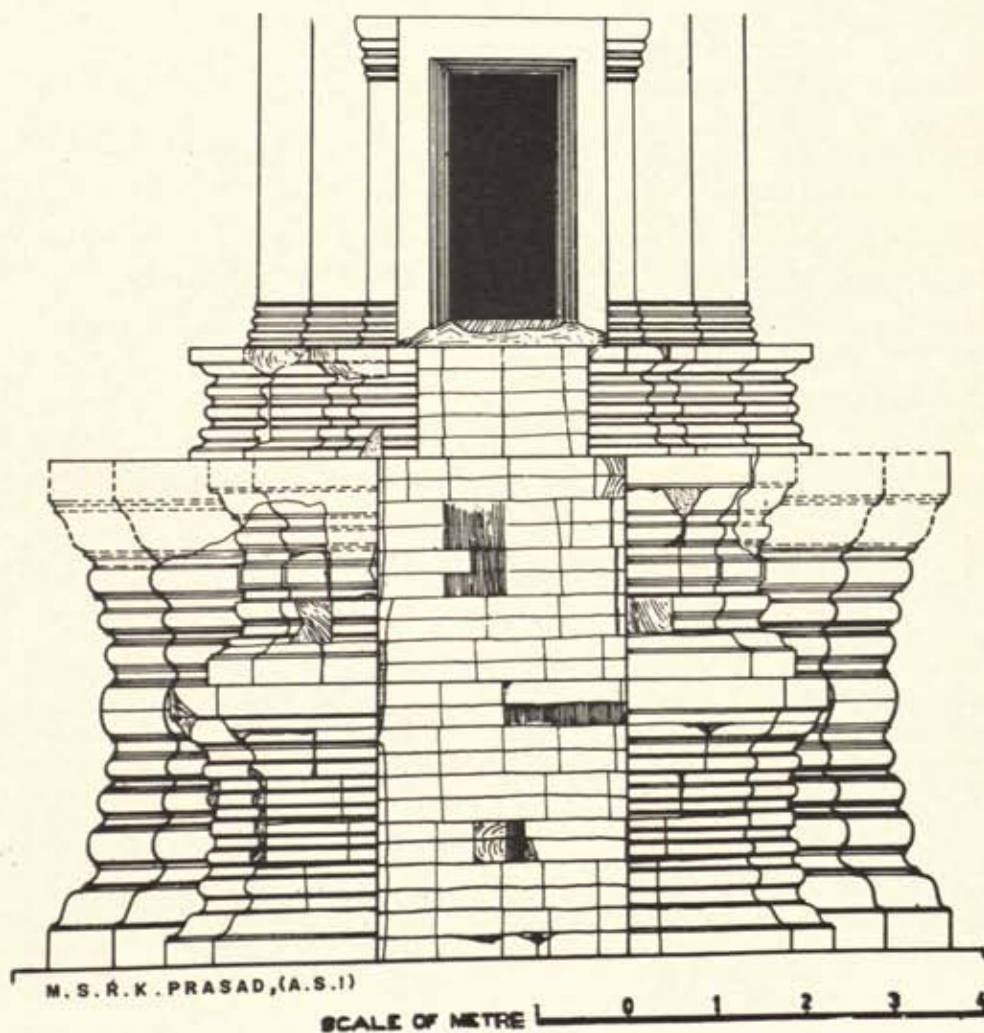
EASTERN ENTRANCE AT NORTHERN CORNER
OF SECOND ENCLOSURE (BEFORE CONSERVATION)

EASTERN ENTRANCE AT NORTHERN CORNER
OF SECOND ENCLOSURE (AFTER CONSERVATION)

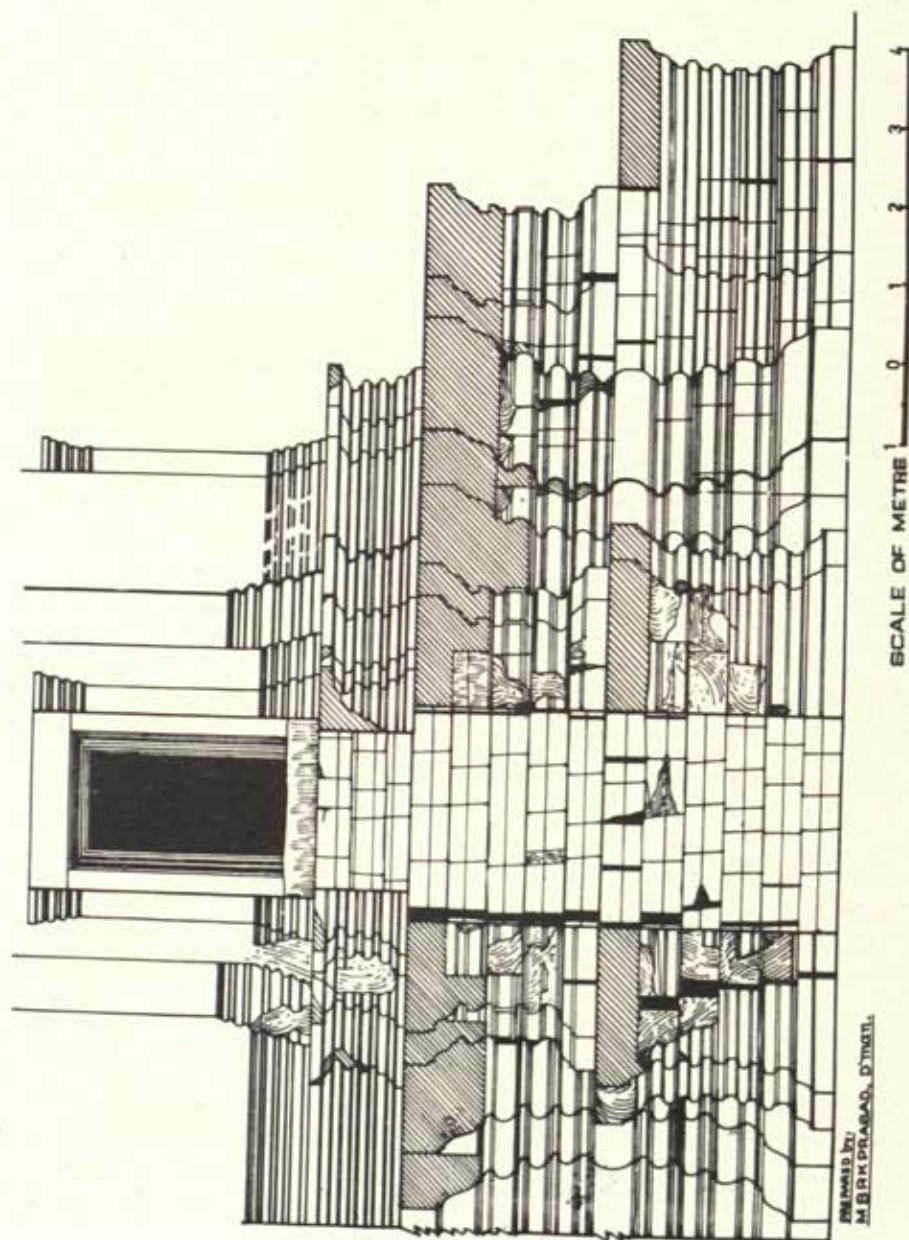
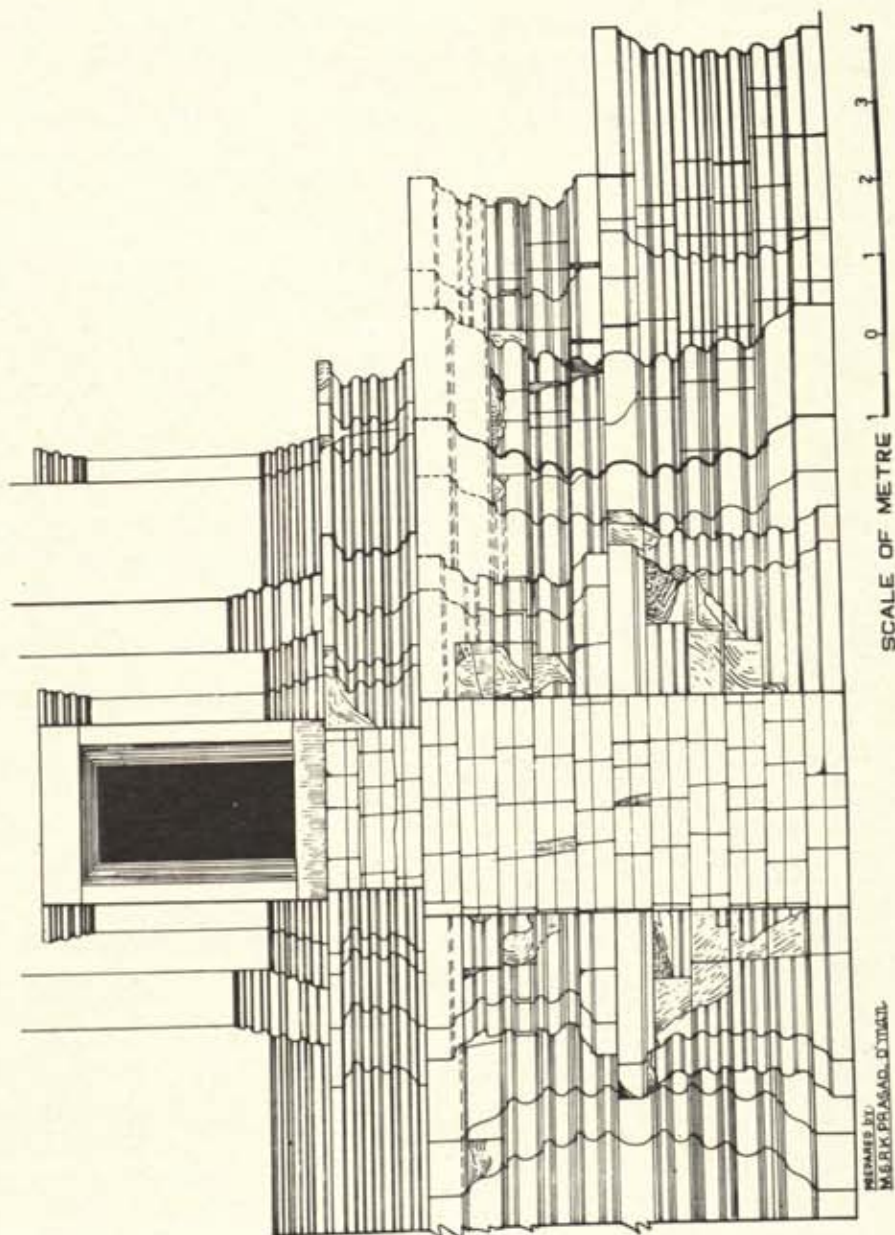
ANGKOR VAT TEMPLE COMPLEX
SIEMREAP (CAMBODIA)
SOUTHERN ENTRANCE AT EASTERN CORNER
OF SECOND ENCLOSURE (BEFORE CONSERVATION)

ANGKOR VAT TEMPLE COMPLEX
SIEMREAP (CAMBODIA)
SOUTHERN ENTRANCE AT EASTERN CORNER
OF SECOND ENCLOSURE (AFTER CONSERVATION)

mentioned one. All the dislodged twenty-one (21) stone members were moved into their proper positions by using horizontal jacks and by human efforts. Another nine (9) members which had fallen down from their original positions were hauled up and fixed in their positions (pl. LV). The structure (fig. 16) was watertightened by filling up the gaps and crevices and grouting and pointing of the joints in the masonry.

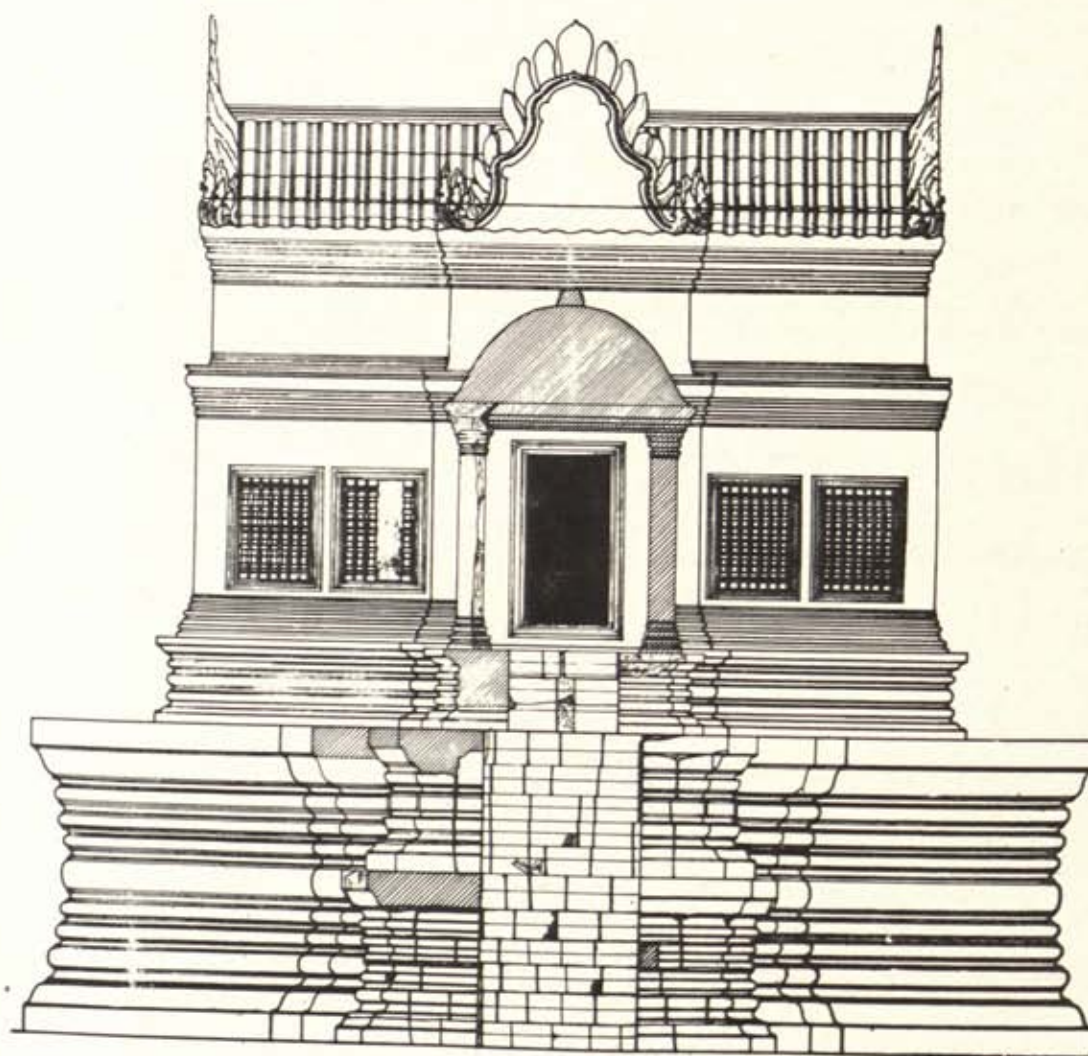
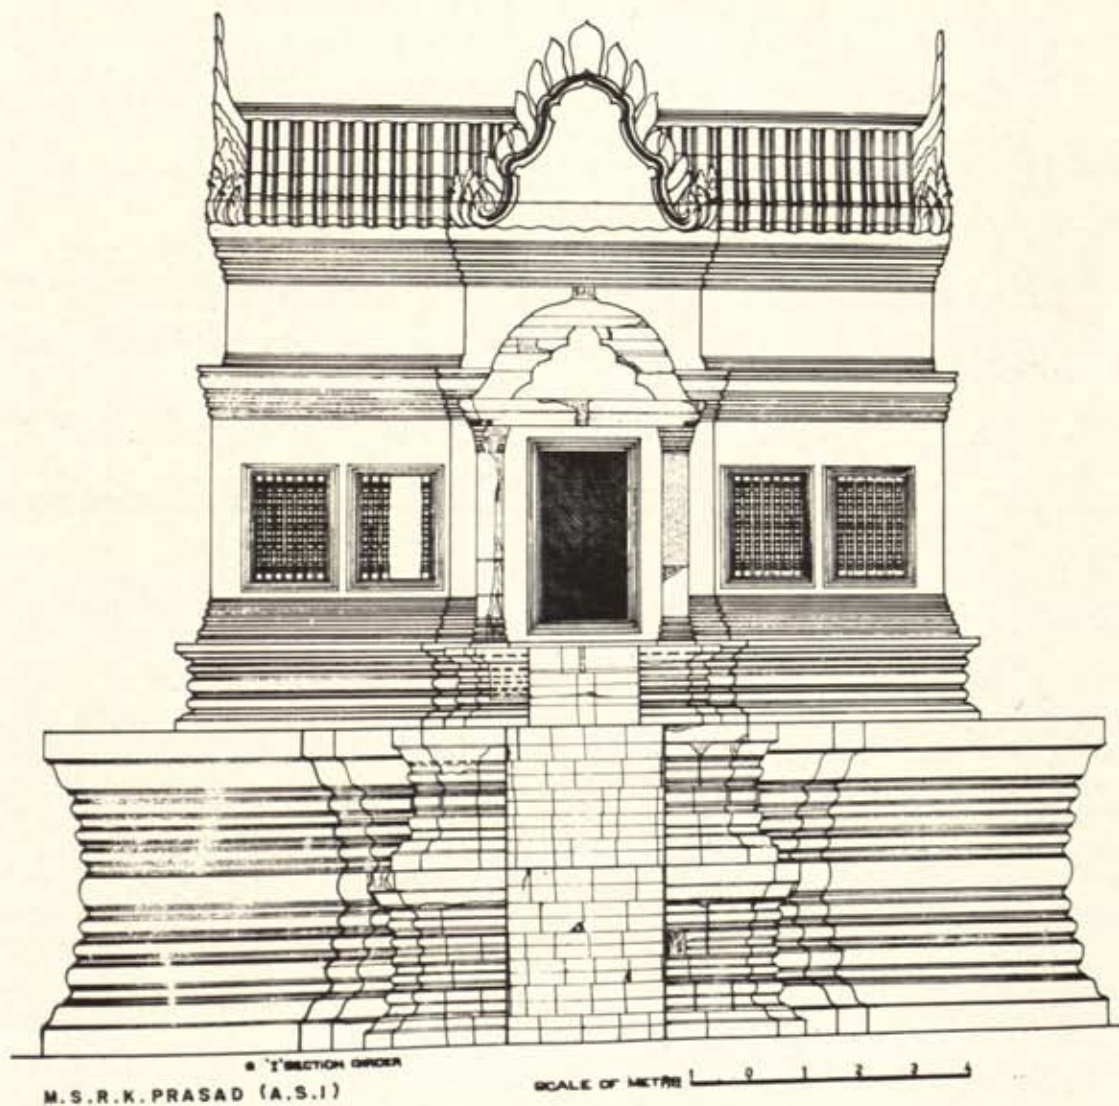
SOUTHERN CENTRAL ENTRANCE OF
SECOND ENCLOSURE (BEFORE CONSERVATION)

SOUTHERN CENTRAL ENTRANCE OF
SECOND ENCLOSURE (AFTER CONSERVATION)

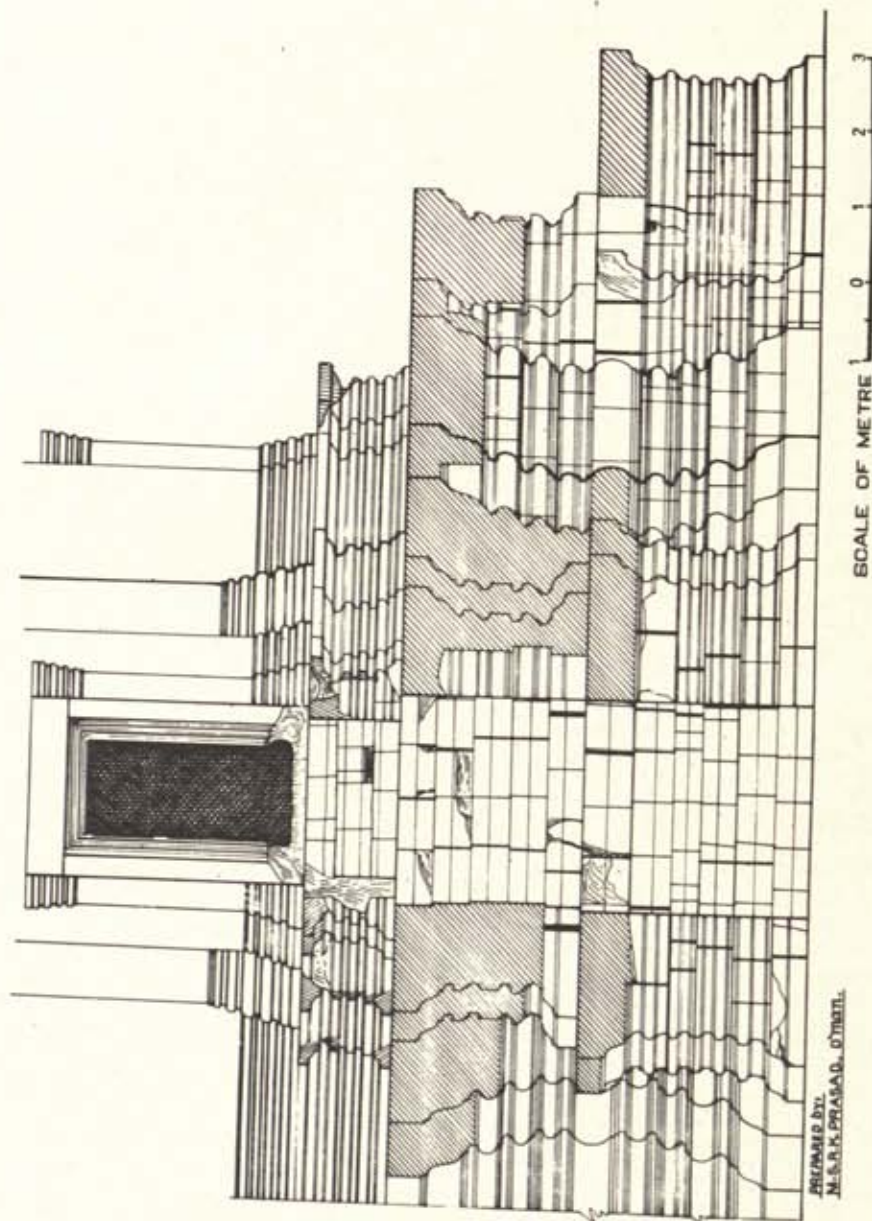
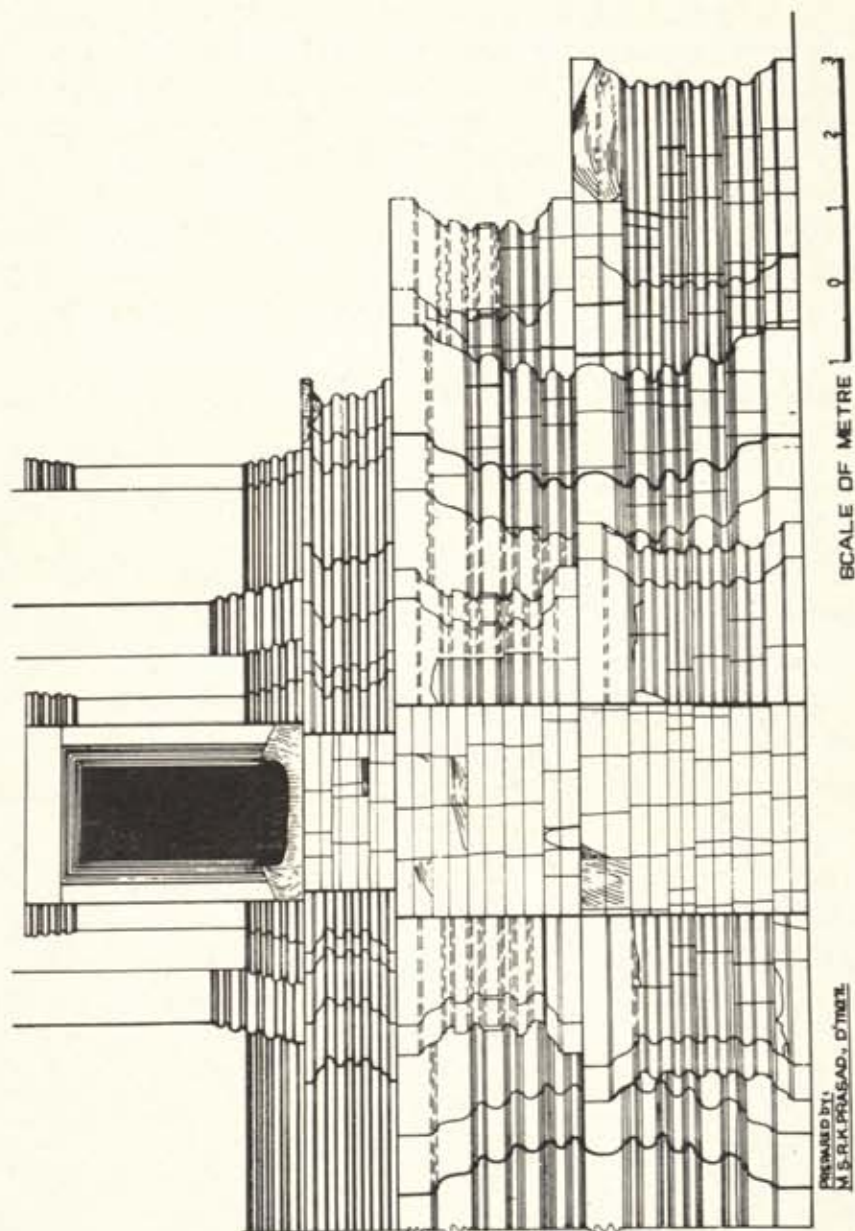
WESTERN ENTRANCE AT SOUTHERN CORNER
OF SECOND ENCLOSURE (BEFORE CONSERVATION)

ANGKOR VAT TEMPLE COMPLEX
SIEMREAP (CAMBODIA)
WESTERN ENTRANCE AT SOUTHERN CORNER
OF SECOND ENCLOSURE (AFTER CONSERVATION)

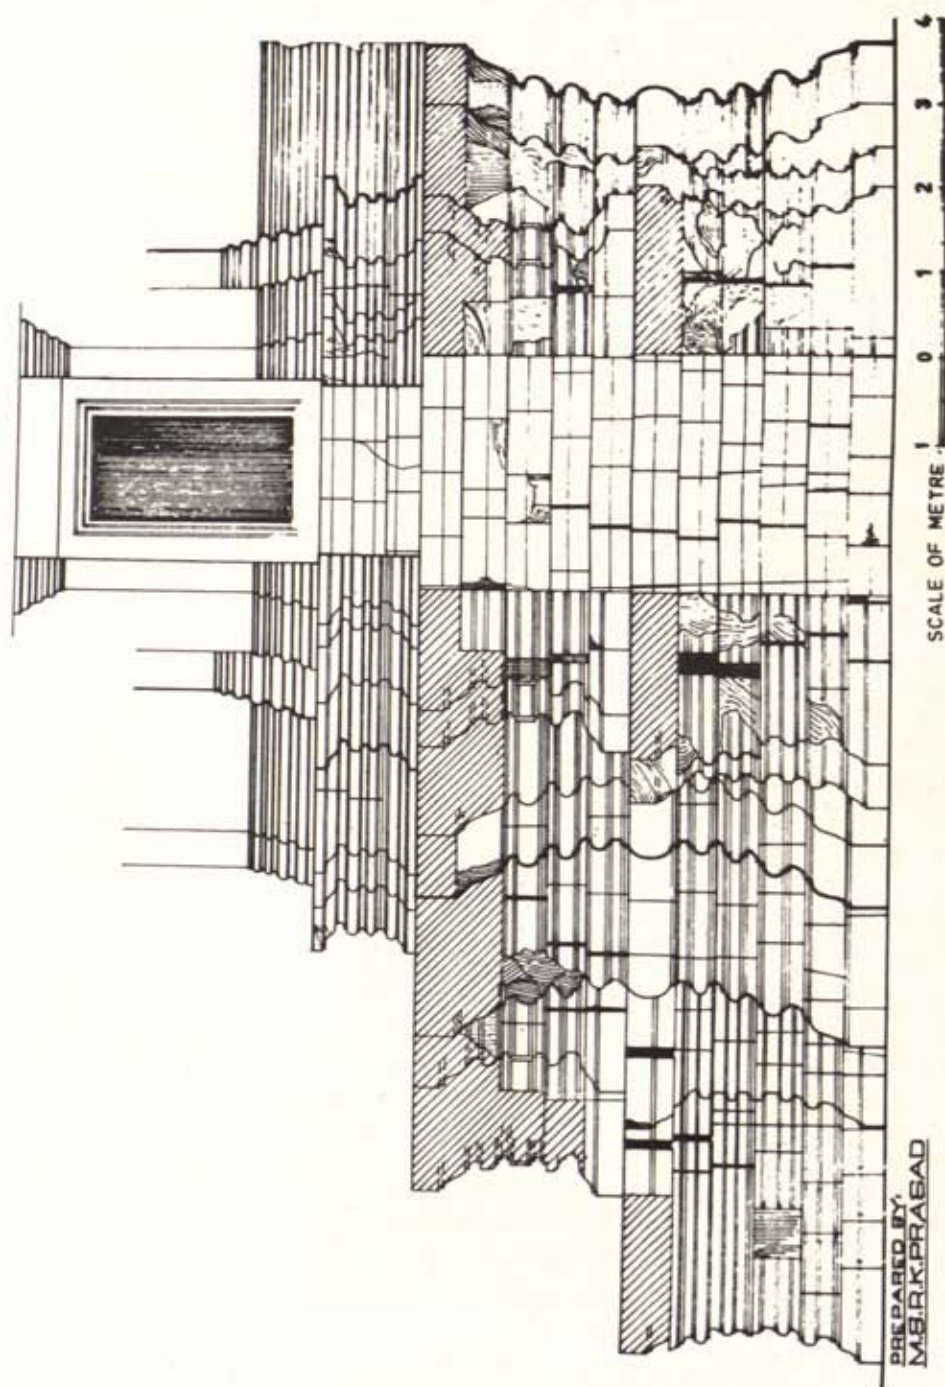
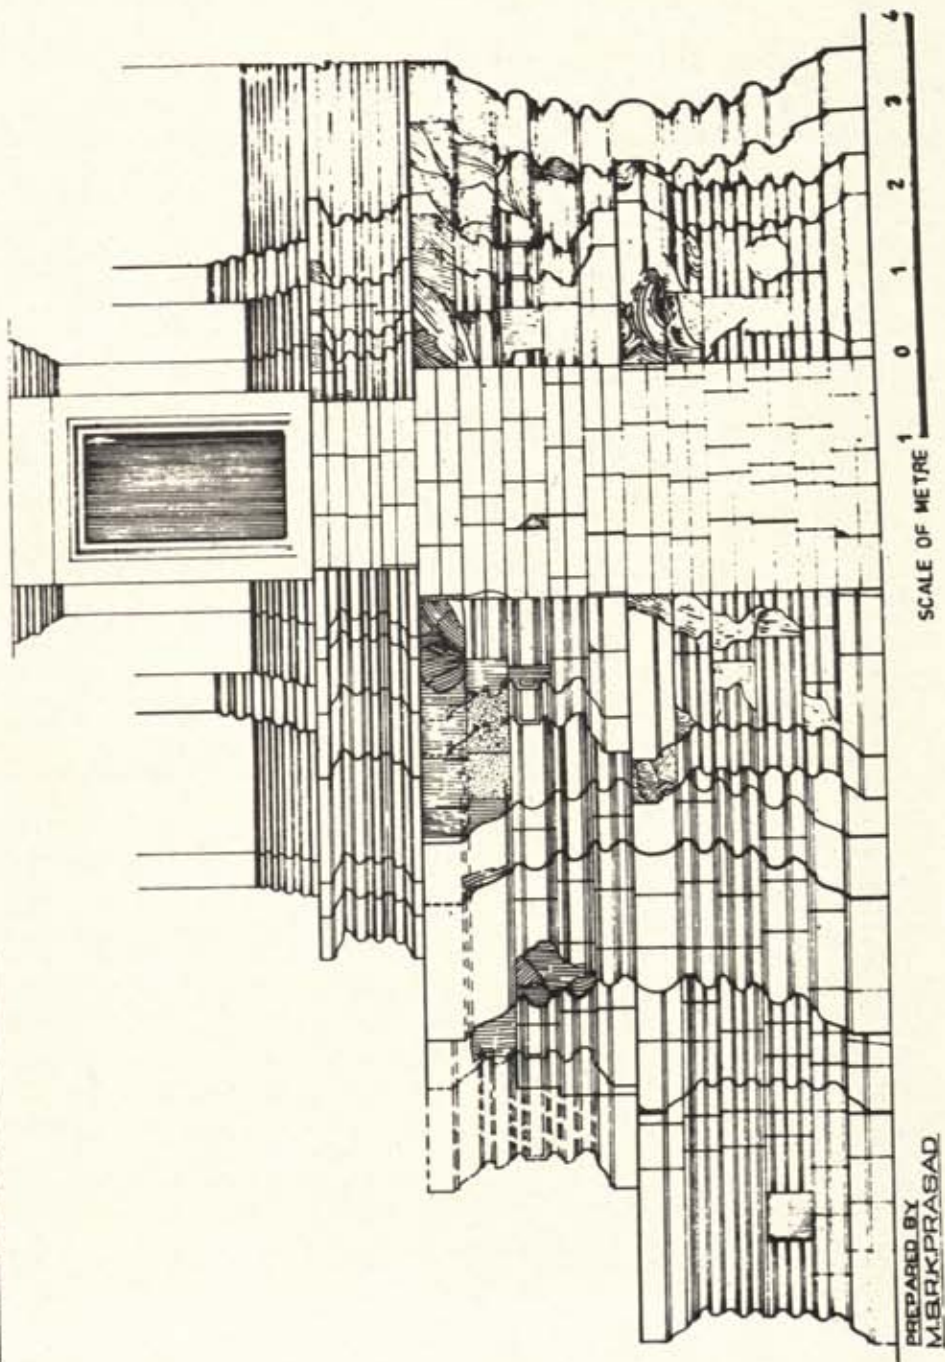
WESTERN ENTRANCE AT NORTH CORNER OF SECOND ENCLOSURE

BEFORE CONSERVATION

AFTER CONSERVATION

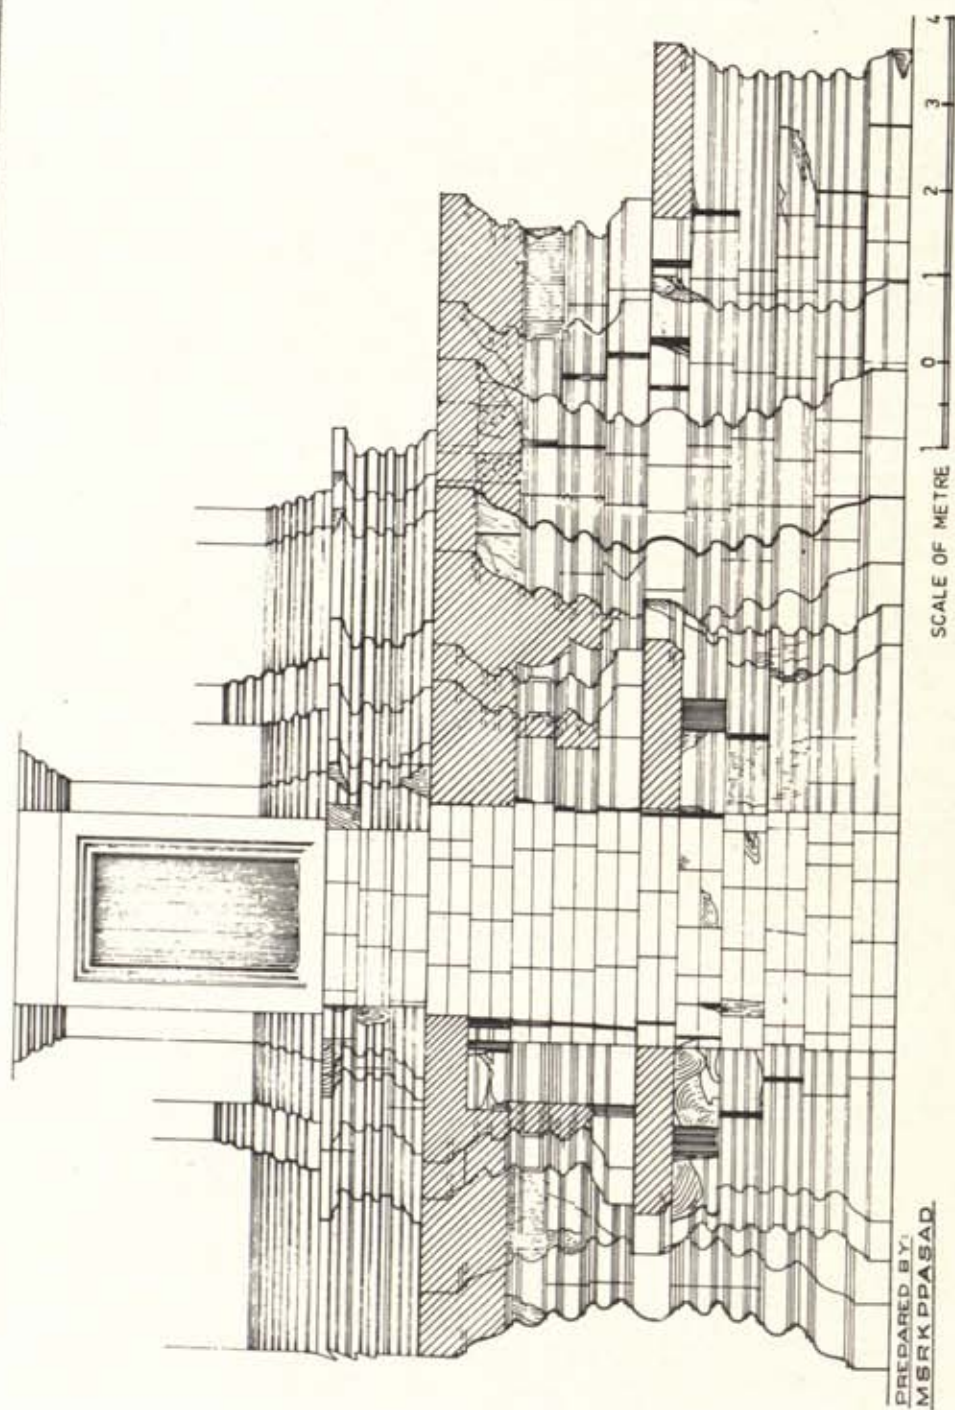
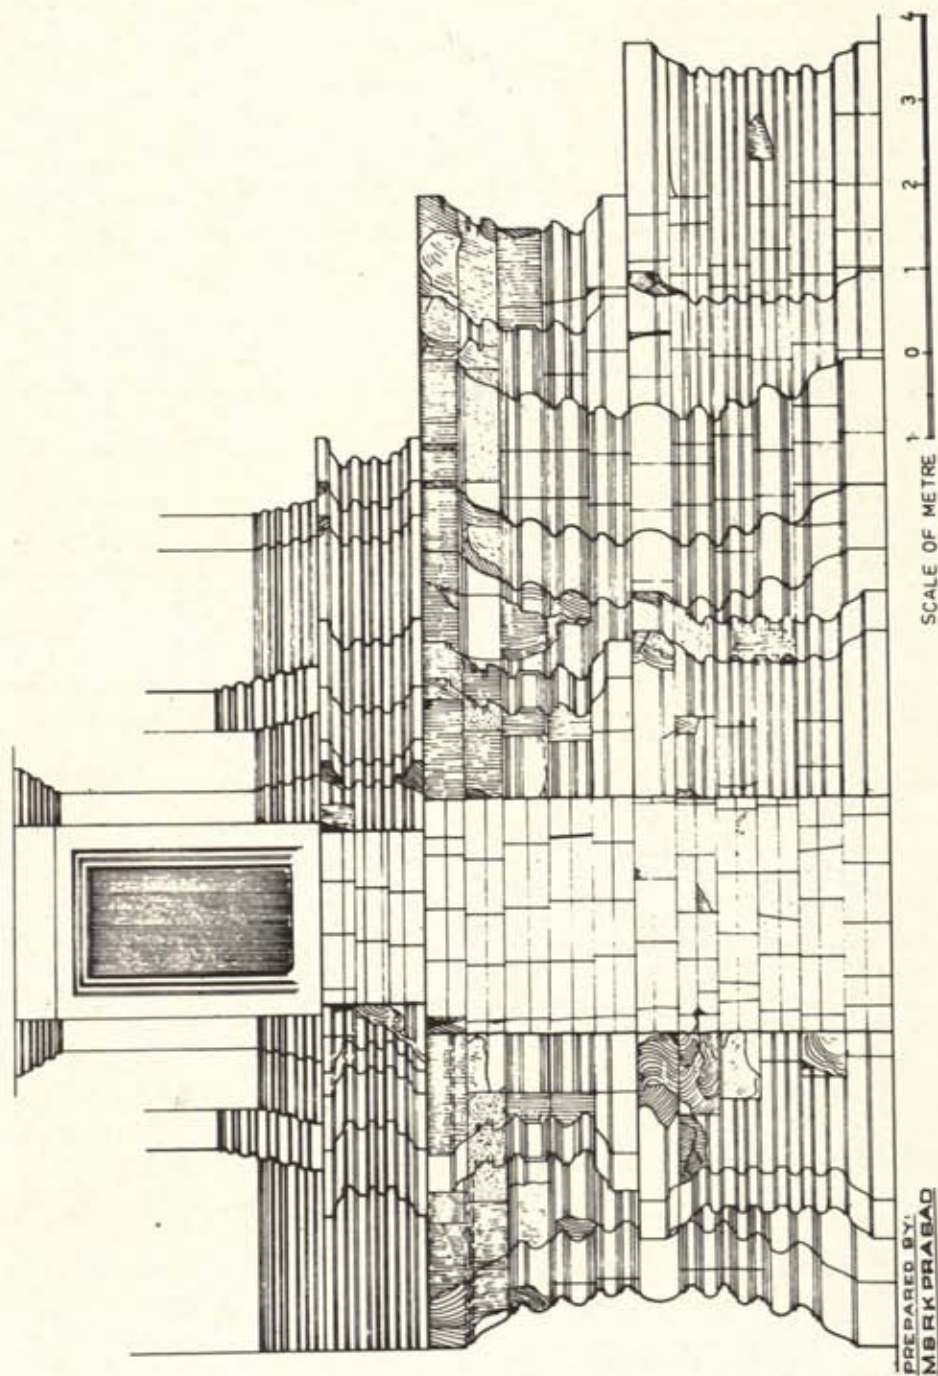
BEFORE CONSERVATION

AFTER CONSERVATION

plinth, balustrades and steps were dismantled and reconstructed as per the original after consolidating the core. While conserving, seventy-four (74) architectural members were dismantled and reset. Another four (4) members which were lying on the ground were identified and hauled up and fixed in their original positions in the structure (pl. LXI). Then the structure was thoroughly watertightened (fig. 21).
